\*\*\* DRAWING 1 \*\*\*  
Curtains opening dimension check

Installation guides

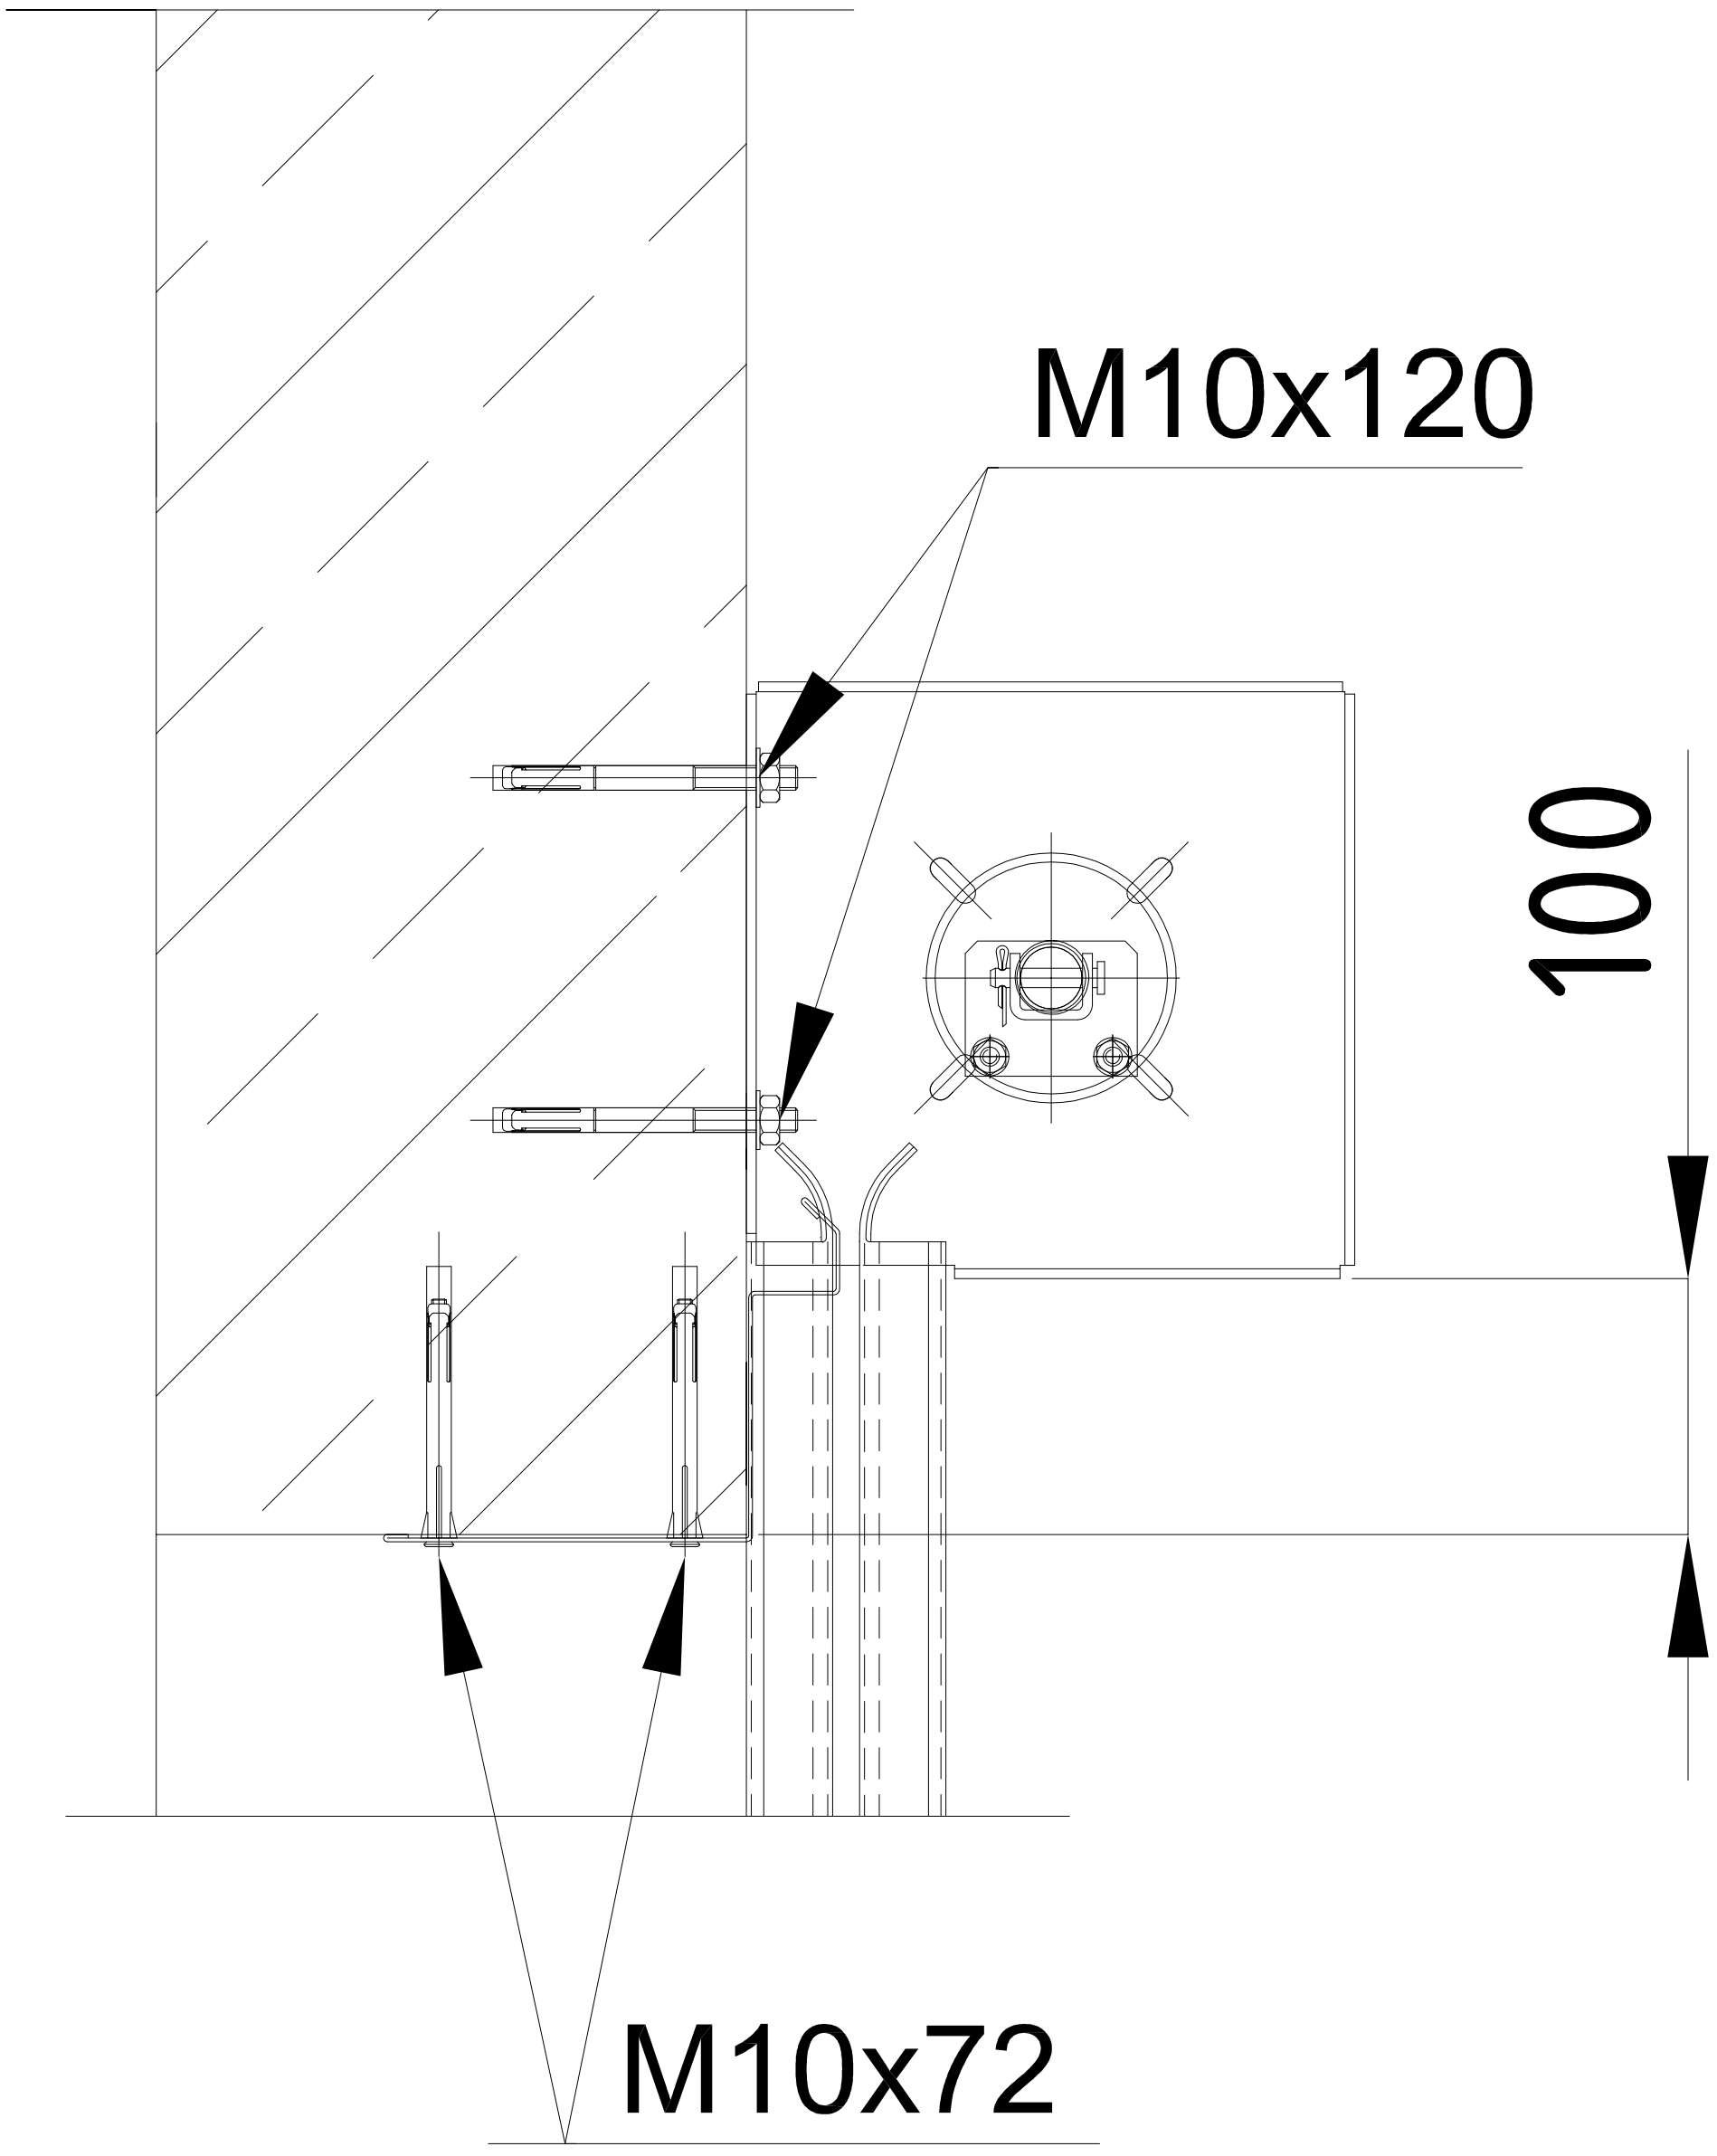
\*\*\* Drawing 3a \*\*\*  
Shaft's consoles

**M10x120**

**100**

**M10x72**
